An eight-year study of nutrient loss before, during and after construction of Colbert Hills Golf Course in Kansas, US was performed to assess the effect of human development on natural streams

Long-term monitoring of nutrient loss in golf course runoff

Kansas State University researchers undertook an eight-year monitoring study to assess the water quality changes with the development of a new championship golf course. Here they present their key observations and conclusions.

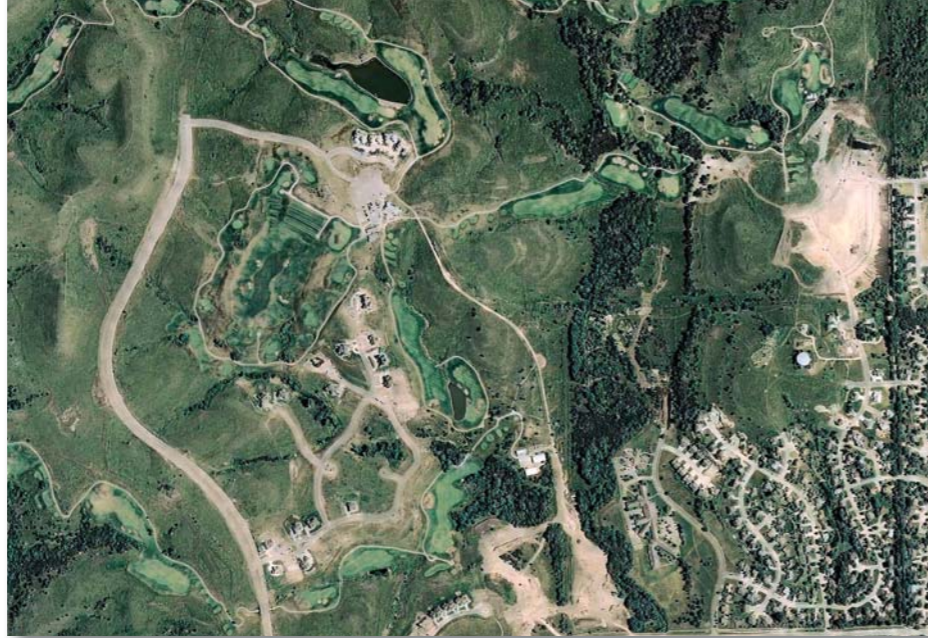
An aerial view of Colbert Hills which resides in the Little Kitten Creek watershed. The land the course was constructed on was originally 89 per cent pasture land and 11 per cent woodland

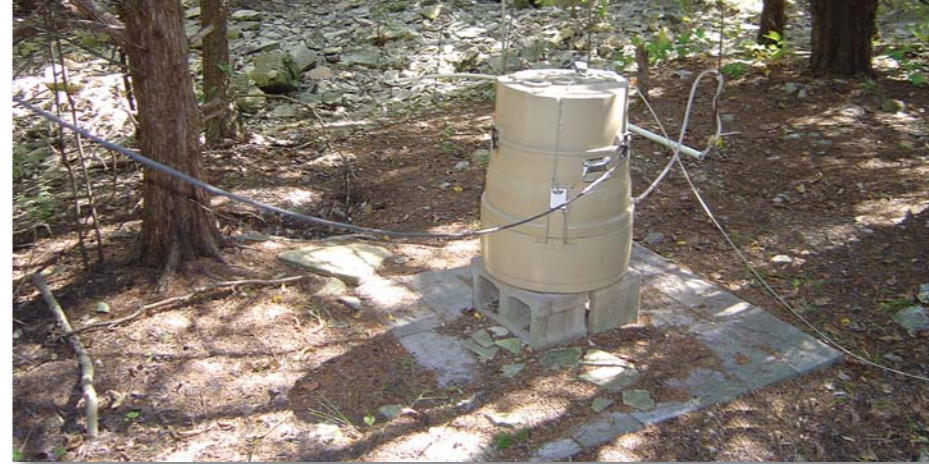
During the pasture cover stage an average value of 0.45mg/L total P exited the watershed. Removal of soil vegetation cover increased the average value to 0.87mg/L total P. Increase of total P concentration in surface water was due to erosion and runoff enhanced rain events and lack of surface vegetation during construction period.

Similarly to what was observed for total N, the concentration of total P in the water decreased during the early stage operation. Vegetation reestablished on the surface was the main cause of the reduction of total P

concentrations in the surface water. The recovery of the surface cover reduced erosion of soil particles and thus reduced transport of nutrients to surface water streams.

Concentrations of total N and total P were found significantly greater during golf course construction than during the pasture

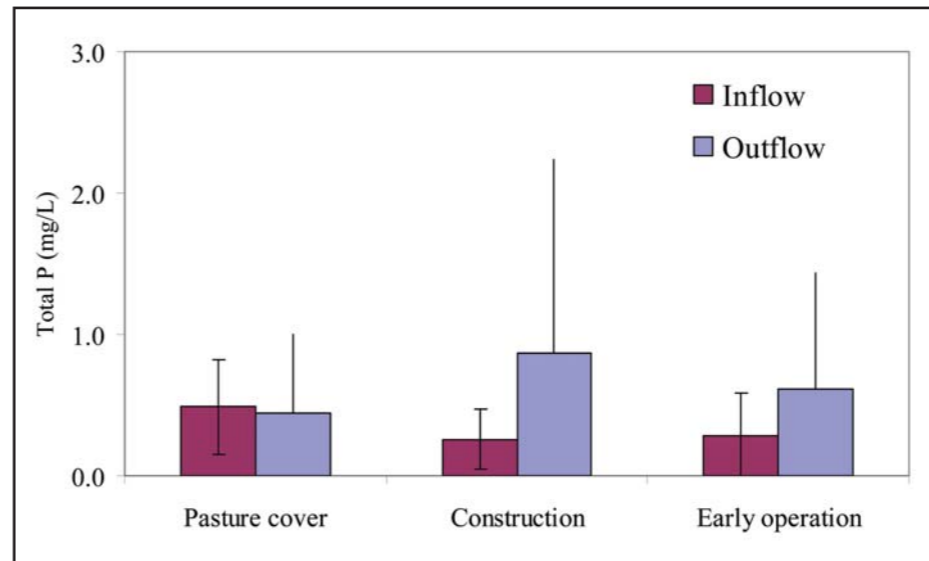
Figure 2: Total P measured in Little Kitten Creek entering and exiting Colbert Hills Golf Course during the three stages of land development

The results for total P in the watershed inflow and outflow, during eight years of study are illustrated in Figure 2. The total P in the inflow did not change significantly over the duration of this study. The average total P values for the pasture cover, construction and early operation stages were 0.49, 0.26 and 0.30mg/L.
